ACCEPTABLE GLASS WINDOW/WINDSHIELD REPAIR PROCESSES AND APPROVED VENDORS

RICHARD J. OLSON

BATTELLE
505 KING AVENUE
COLUMBUS, OH 43201

MATERIAL AND PROCESS SPECIFICATION REPORT FOR 09/91 - 12/31/95
CONTRACT NUMBER FO9603-90-D-2217-SD02

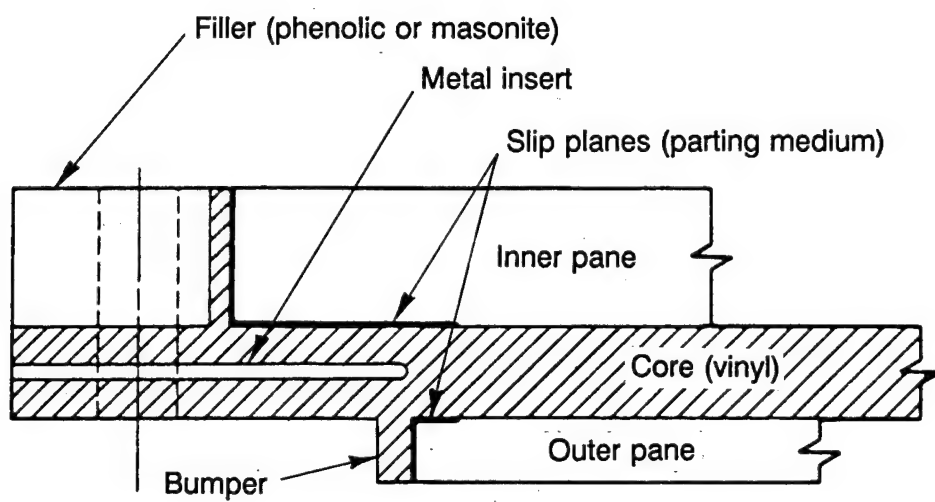
Figure 2.1 C/KC-135 and B-52 W/WS General Construction

Figure 2.1 shows the general construction of the glass C/KC-135 and B-52 W/WS. The W/WS have a three-part glass and vinyl laminate construction. The inner layer is thick, heat-strengthened plate glass designed to withstand cabin pressure forces. A transparent, plasticized, polyvinyl butyral core layer acts as the "fail-safe" load carrying member and prevents shattering in the event of inner ply failure. The outer ply is a relatively thin layer of heat-strengthened glass with no structural significance, but it provides rigidity and a scratch-resistant surface. A phenolic or masonite filler strip, located around the edge of the W/WS, and a metal filler strip embedded in the vinyl provide the means to attach the W/WS to the airframe. Vinyl or vinyl and rubber bumpers protect the edges of the glass plies.

An integral part of the C/KC-135 and B-52 W/WS construction is slip planes or a parting medium at the edges of the glass. A slip plane is located between both the inner glass ply and the vinyl and the outer glass ply and the vinyl as shown in Figure 2.1. The slip planes are thin strips of material at the glass-vinyl interface that keep the glass from bonding to the

As a result of aging, cracks may occur in the vinyl. Over time, attack by ultraviolet radiation and high temperatures also causes the vinyl to lose ductility. Eventually, cracks may form around the periphery of the W/WS in proximity to the metal insert as the glass and vinyl try to move relative to one another. Vinyl cracks significantly weaken the structure of the W/WS by putting flaws directly in the load path between the transparency and the airframe for bird impact loads. Per Figure 2.1, only the vinyl extends out to the mounting holes, not the glass. Therefore, if the vinyl is cracked near the metal insert, the W/WS could just "punch out" of the frame into the cabin in a bird impact situation. The vinyl layer is also the pressure "fail-safe" layer, so vinyl cracks are quite important.
